Contract #: 04-0120F4Cty: SF/ALA Rte: 80 PM: 13.2/13.9File #: 1.28**WELDING INSPECTION REPORT****Resident Engineer:** Casey, William**Address:** 333 Burma Road**City:** Oakland, CA 94607**Report No:** WIR-026714**Date Inspected:** 15-Nov-2011**Project Name:** SAS Superstructure**OSM Arrival Time:** 700**Prime Contractor:** American Bridge/Fluor Enterprises, a JV**OSM Departure Time:** 1730**Contractor:** American Bridge/Fluor Enterprises, a JV**Location:** Job Site**CWI Name:** As noted below.**CWI Present:** Yes No**Inspected CWI report:** Yes No N/A**Rod Oven in Use:** Yes No N/A**Electrode to specification:** Yes No N/A**Weld Procedures Followed:** Yes No N/A**Qualified Welders:** Yes No N/A**Verified Joint Fit-up:** Yes No N/A**Approved Drawings:** Yes No N/A**Approved WPS:** Yes No N/A**Delayed / Cancelled:** Yes No N/A**Bridge No:** 34-0006**Component:** OBG Component**Summary of Items Observed:**

13W/14W "D" Plate

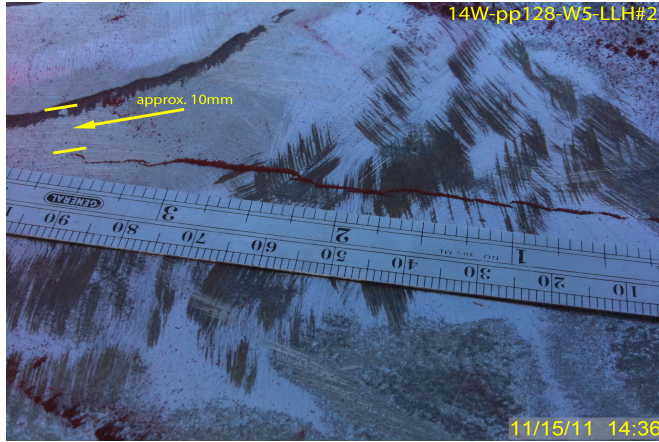
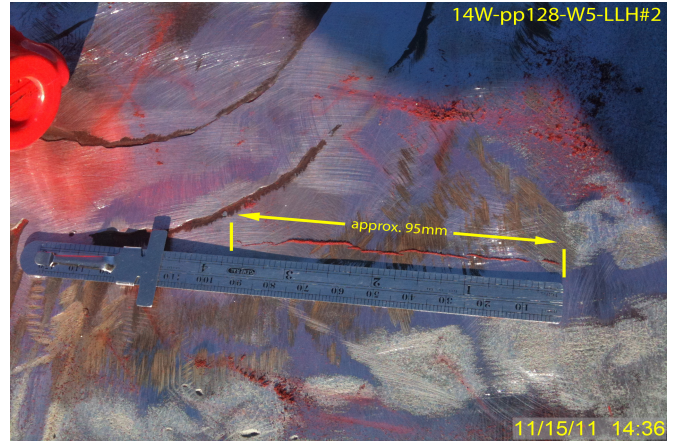
During random observation of QC Magnetic Particle (MT) testing a linear indication measuring approximately 90mm in length was discovered in the base material adjacent (approximately 10mm from the toe) to the lifting lug hole designated as 14W-PP128-W5-LLH#2. See attached photograph for visual representation.
